Manhole Inspection Summary

Manhole # S69A1_010MH

Location Address: **2200 Van Deman St.**

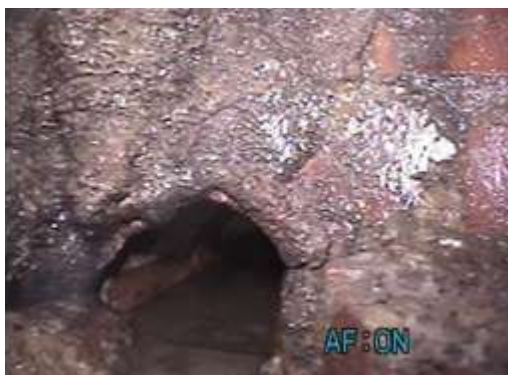
Defect 2

[dae] deposit attached encrustation around the incoming 9 connection--12 to the 12.

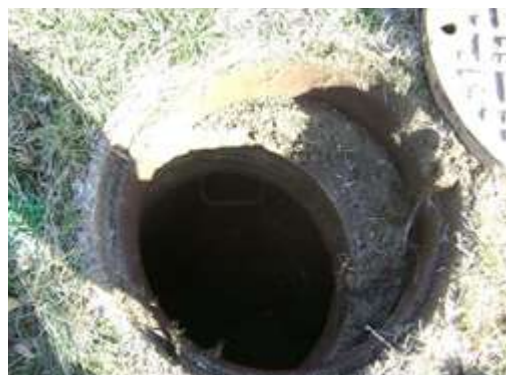
Defect 1

Frame Offset: **6** (in.) Condition: ☒ Sound ☐ Cracked ☐ Leaks

6 in. frame offset

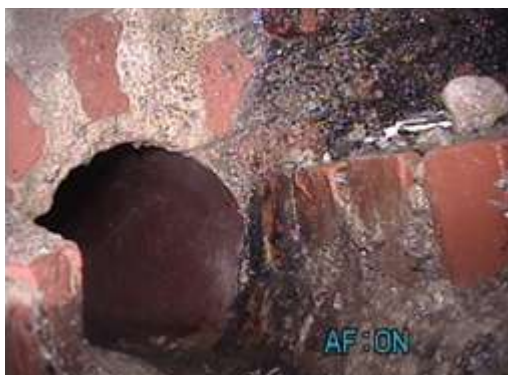
Defect 3

[dae] deposit attached encrustation along bench and channel---right side of picture

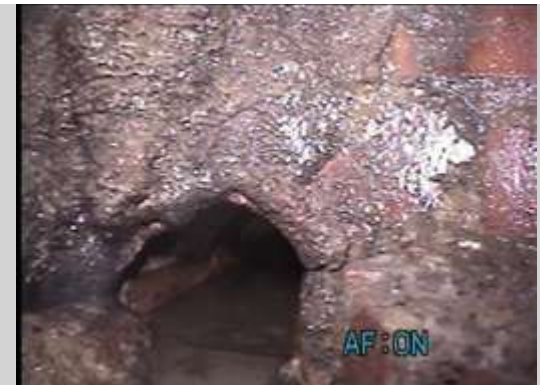
9 O'Clock Inflow

encrustation around connection
